Report No. 14 CIA/PIR 75054

DATE OCTOBER 1966

CIA IMAGERY ANALYSIS DIVISION

ITEM OF INTEREST NO. 1: Hanoi/Lao Cai Rail Line

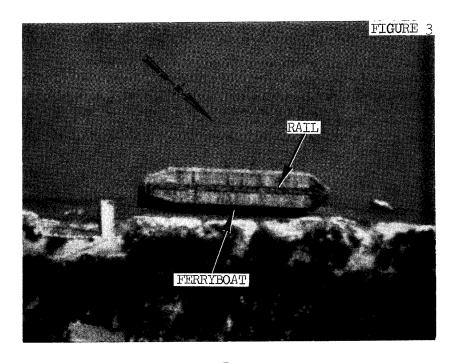
Photography reveals a serviceable rail ferry approximately 0.2 nm W of the destroyed Viet Tri Railroad and Highway Bridge at UTM WJ 465551 (Figure 4). A possible rail ferry-boat is located 0.1 nm E of the bridge at UTM WJ 468550 under some over-hanging trees. A confirmed rail ferryboat measuring approximately 110' x 20' is located about 0.8 nm E of the bridge at UTM WJ 475560, (Figure 3).

Construction has been undertaken on 4 new ferry approaches (i.e., 2 on either side of the river) approximately 0.2 nm W of the serviceable ferry (Figure 4). Ties have been laid on parts of the two southern approaches, but work has been hampered by high water on the northern approaches. Construction has not commenced on the ferry slips.

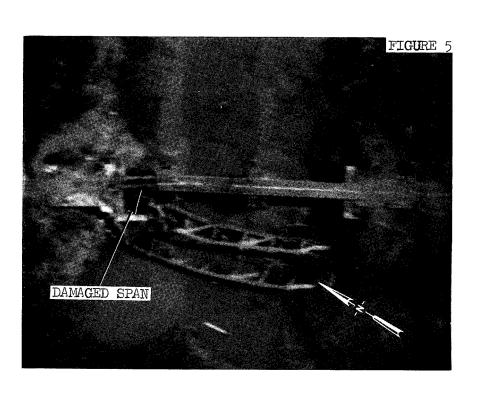
ITEM OF INTEREST NO. 2: Hanoi/Lao Cai Rail Line

Photography reveals that 1 span of the 3-span deck-beam Pho Hop Railroad Bridge has been heavily damaged and is undergoing repair. The bridge is currently unserviceable.

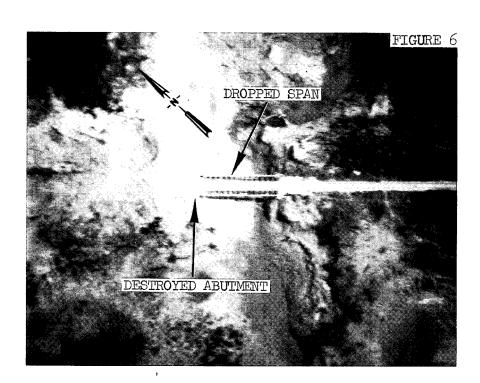
ITEM OF INTEREST NO. 3: Hanoi/Lao Cai Rail Line

Photography reveals that the single-span half-through truss Khe Se Railroad Bridge is unserviceable. One abutment has been destroyed and the span has been dropped.

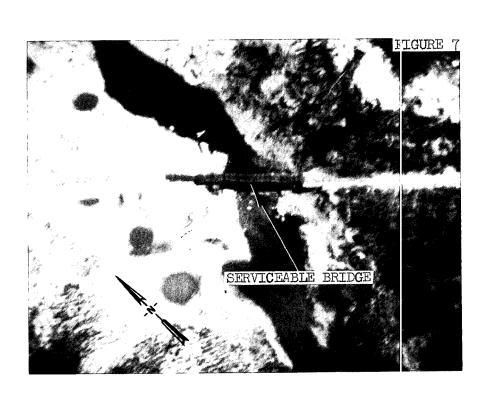
ITEM OF INTEREST NO. 4: Hanoi/Lao Cai Rail Line

Photography reveals that the 3-span, deck-type Lang Khay Railroad Bridge has been repaired and is now serviceable.

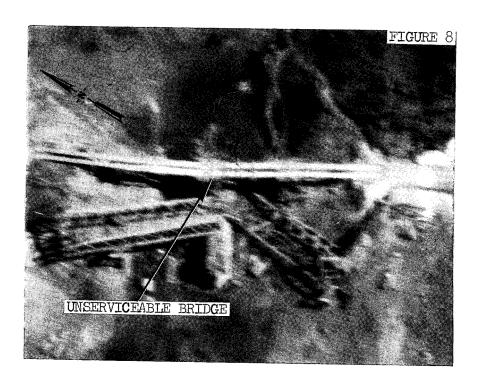
ITEM OF INTEREST NO. 5: Hanoi/Lao Cai Rail Line

Photography reveals that the 8-span, deck-beam Lang Bun Railroad Bridge is undergoing repairs and is unserviceable.

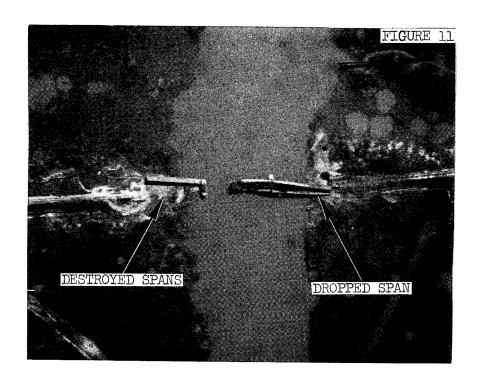
ITEM OF INTEREST NO. 1: Hanoi/Dong Hoi Rail Line

Additional bomb damage is noted on Dien Chau Railroad Bridge. All 8 spans of the bridge are now damaged or destroyed. Three deck-beam spans had been destroyed previously. The remaining original half-through truss span has now been partially dropped. In addition, four deck-beam spans and 4 temporary piers have been destroyed.

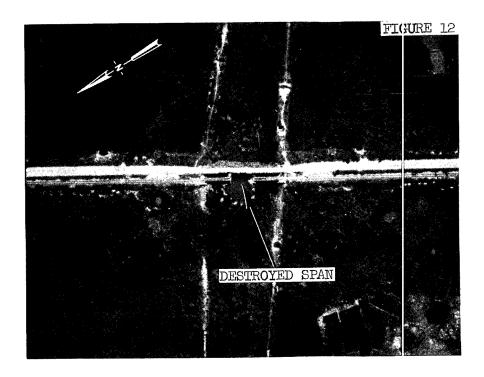
ITEM OF INTEREST NO. 2: Hanoi/Dong Hoi Rail Line

Photography reveals the center span of the 3-span, deck-type Long Ngoc Railroad Bridge has been destroyed.

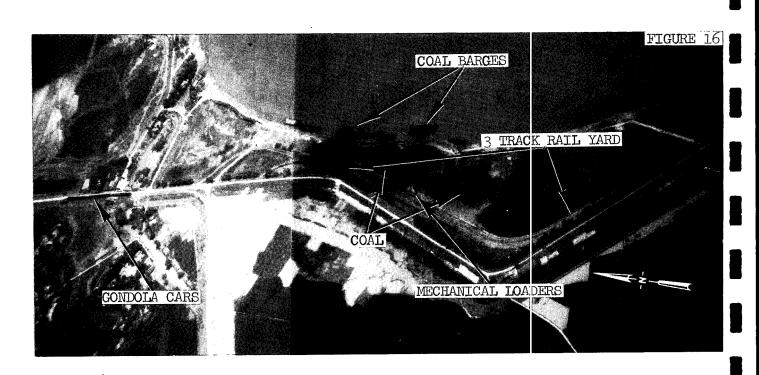
ITEM OF INTEREST NO. 1: Hanoi/Haiphong Rail Line

It has now been determined that a previously reported rail-to-water transshipment point about 3 nm NW of Hai Duong (Report No. 1) is a coal transloading area. A spur track leads from the main line to a 3-track yard on the west bank of the Song Thai Binh (River). Coal is being transferred between barges and gondola cars, and large quantities of coal are stockpiled in the area.
